# THE CHALLENGER CASE STUDY

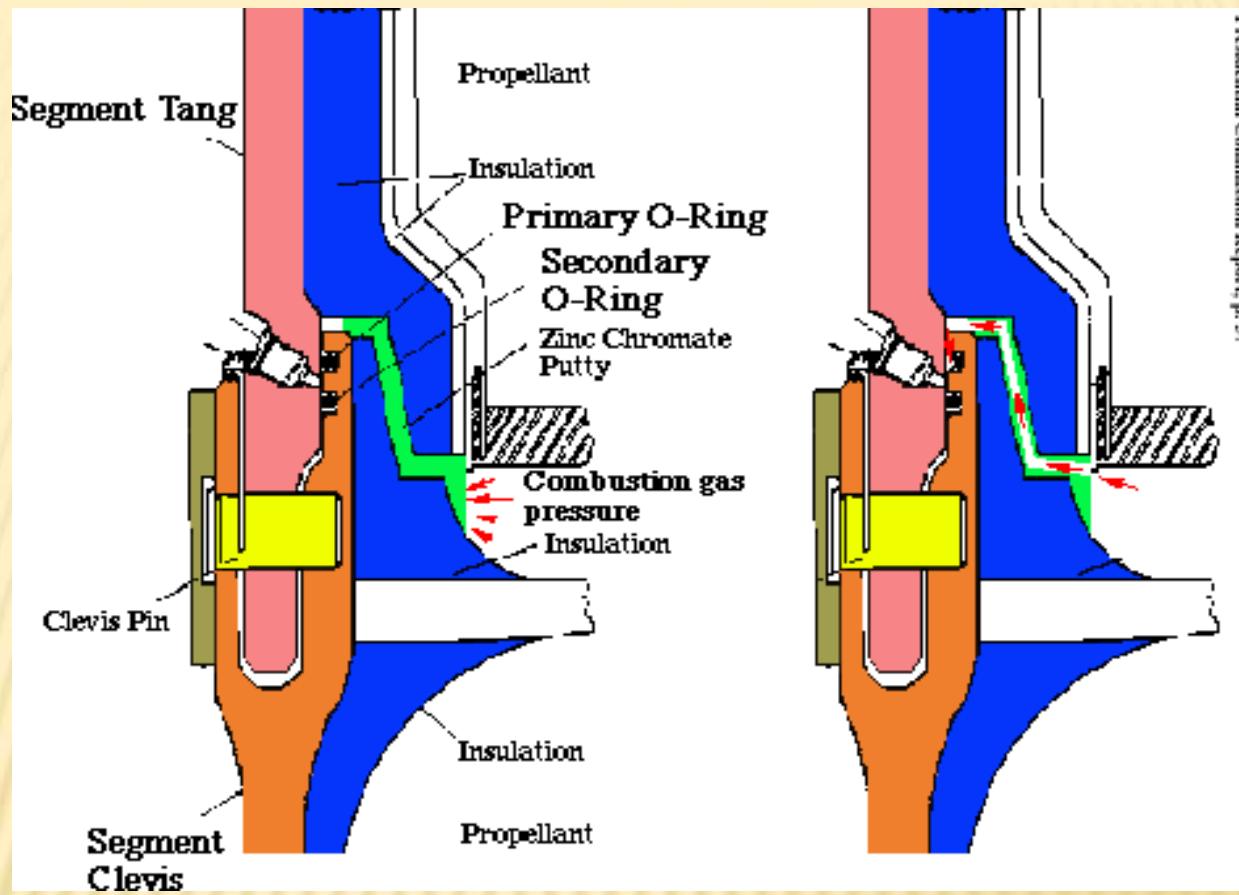
The Solid Rocket Boosters

- Increasing O-ring compression in order to decrease Joint Rotation was taken for analysis where Joint rotation is the opening of gap between the tank and clevis which was caused due to ballooning of cylinder and changes were made in the design.
- A new problem was deduced after the flight of the second shuttle mission. Examination of the booster field joints revealed that the O-rings were eroding during flight. Study was conducted about the effects of O-ring resiliency at low temperatures. New steel billets were ordered for the redesign of the tank.
